Study on Diagnostic Techniques for Detecting
Degradation of Underground Transmission Cables
using Chemical Analysis Methods

November 2018

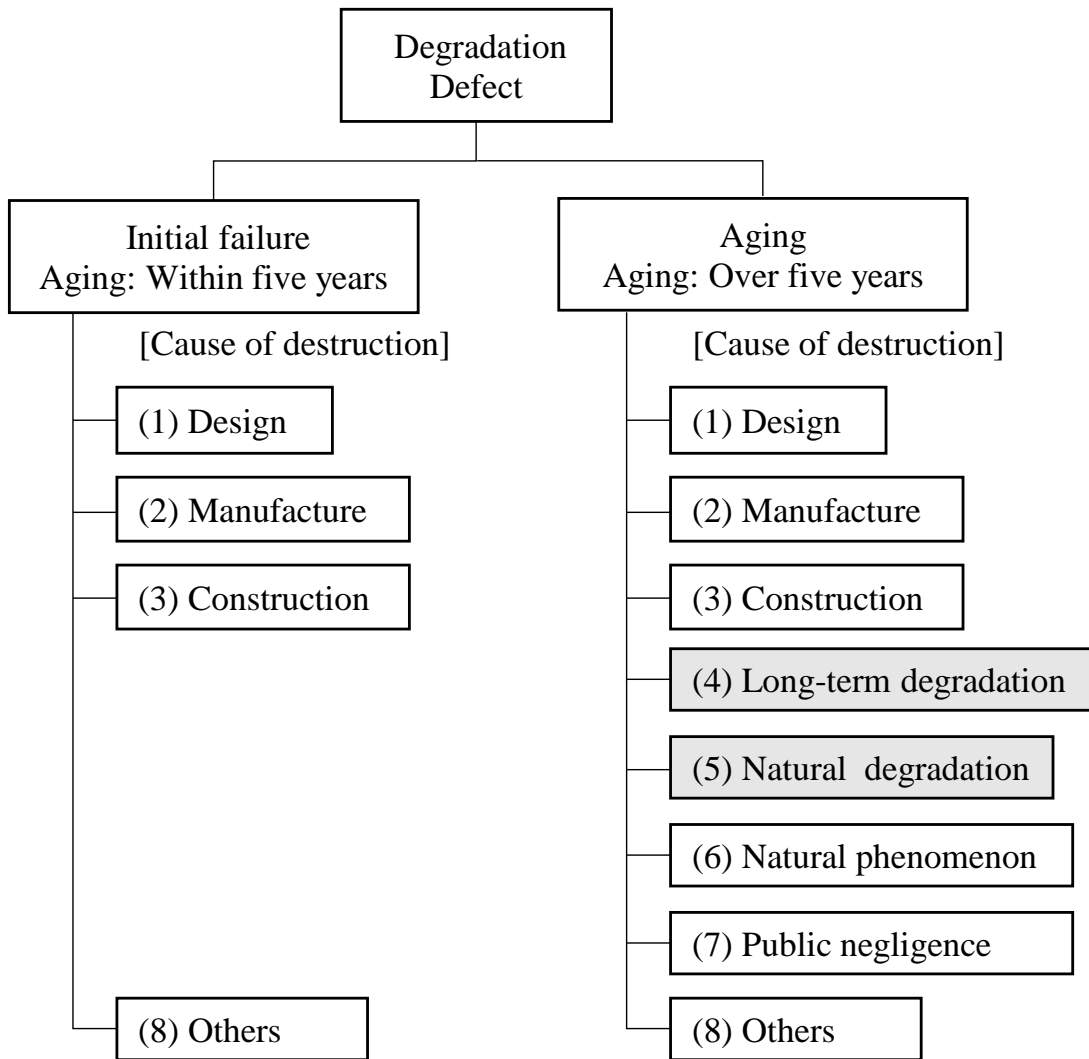
Fig 1.1 Classification of degradation and defects that cause insulation breakdowns [1]

Fig 1.1 shows the classification of degradation and defects that cause insulation breakdowns [1]. The degradation and defects presumed through aged cables are mainly long-term degradation ((4) in Fig 1.1) and natural degradation ((5) in Fig 1.1). The factors causing long-term and natural degradation are water trees and chemical deposits in CV cables, and core shift and the overlap of oil gap in OF cables [1]. The difference between long-term degradation and natural degradation is the presence or absence of initial defects (the “presence” of initial defects is “long-term degradation”). Contaminations at the time of manufacture and traumas at the time of laying are examples of initial defects.

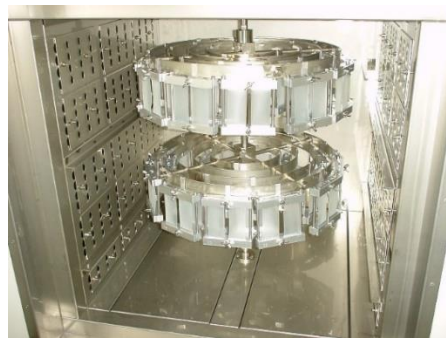
Fig 2.2 Heated situation in gear-type aging oven

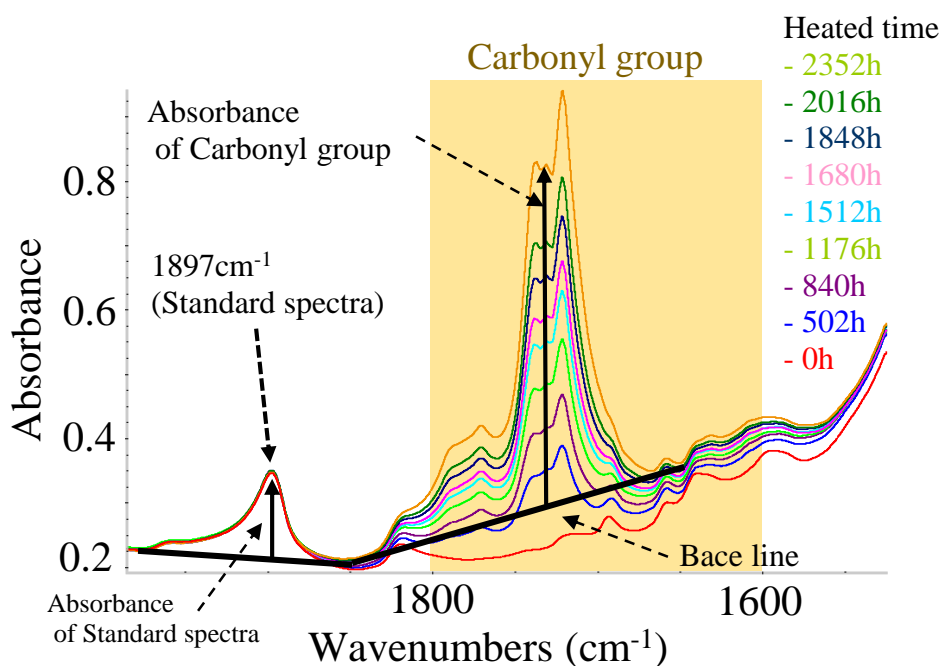
Fig 2.6 Infrared absorption spectra of XLPE (at the heated temperature of 140 °C)

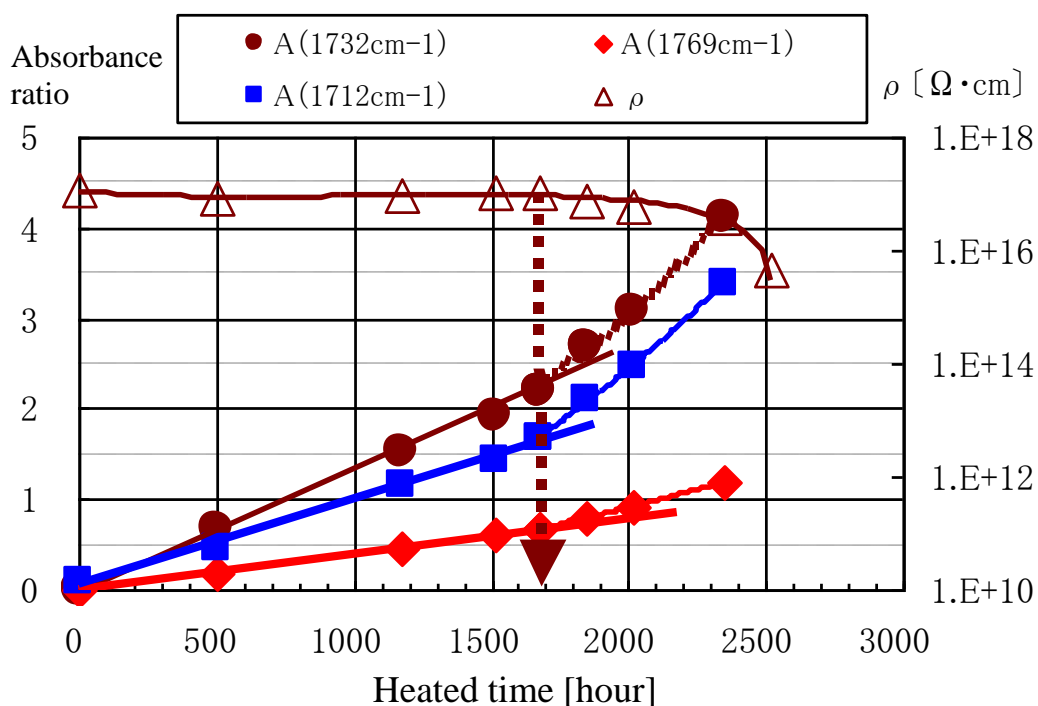
Fig 2.9 Change over time of absorbance ratio at 1712, 1732, and 1769 cm^{-1} (at the heated temperature of 140 $^{\circ}\text{C}$)

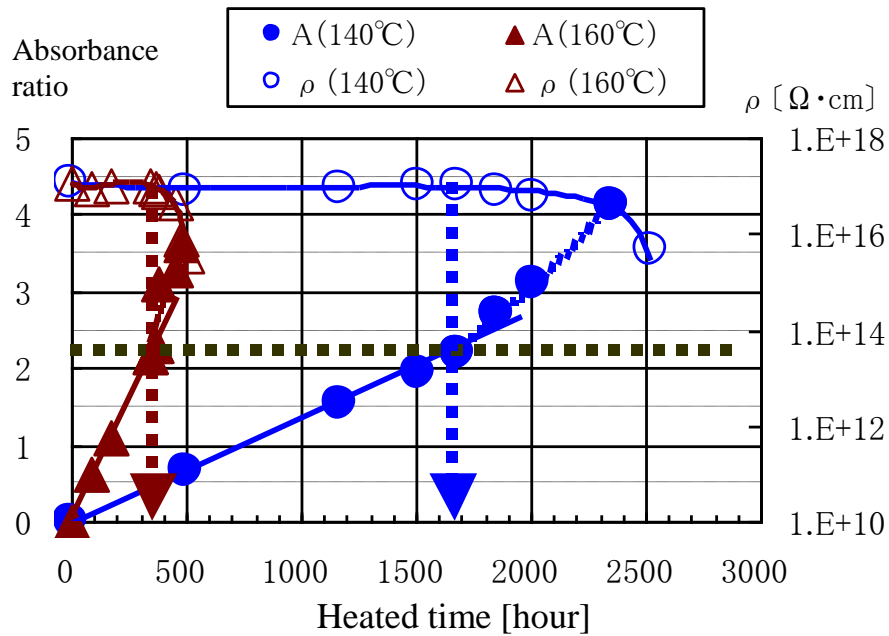
Fig 2.10 Change over time of absorbance ratio at 1732 cm^{-1} (at the heated temperature of $140 \text{ }^\circ\text{C}$)

Fig 2.10 shows the change over time of the absorbance ratio at 1732 cm^{-1} and volume resistivity at the heated temperatures of 140 $^{\circ}\text{C}$ and 160 $^{\circ}\text{C}$. In addition, Fig 2.11 shows the change over time at the heated temperature of 180 $^{\circ}\text{C}$. The trends in the absorbance ratio and volume resistivity values were the same for the three temperatures. Moreover, the absorbance ratio at the end of the linear trend was the same 2.2 at the three temperatures.

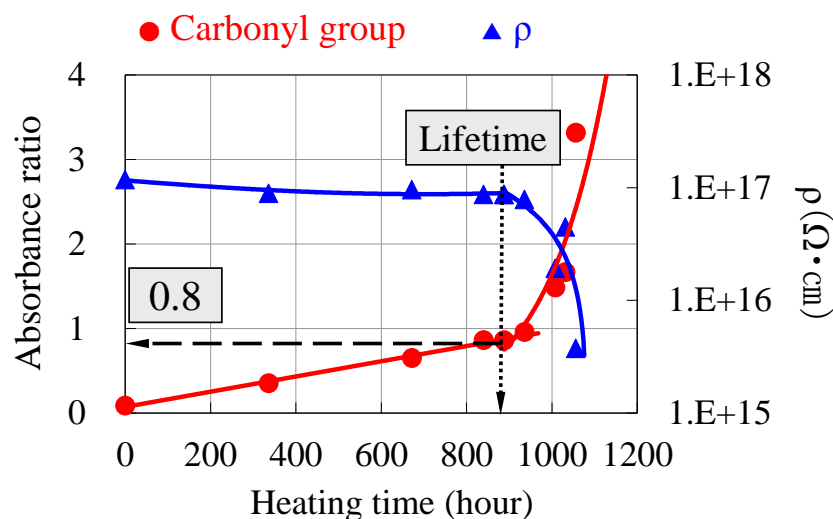
Fig 2.12 Change over time of absorbance ratio at 1732 cm⁻¹ with XLPE made by Company B (heated temperature = 140 °C)

Fig 2.12 shows the change over time of the absorbance ratio at 1732 cm⁻¹ and volume resistivity at the heated temperature of 140 °C with the XLPE made by Company B. The lifetime value of the carbonyl group was 0.8. Other degradation characteristics were the same as the characteristics of Company A.

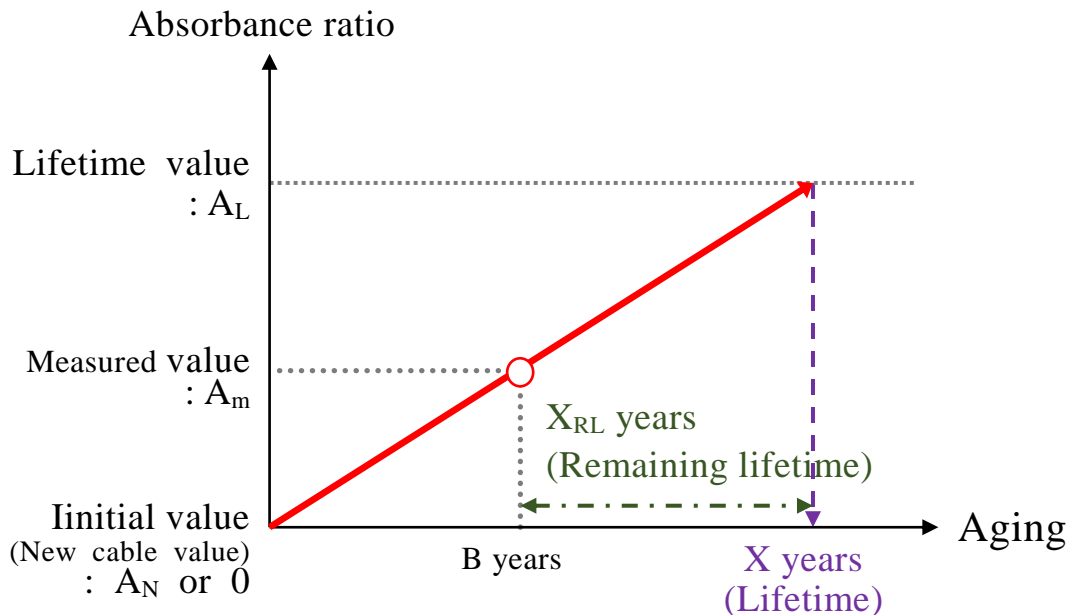
Fig 2.13 Summary of lifetime diagnostic methods

Fig 2.13 shows the summary of the lifetime diagnostic methods. The new value of the carbonyl groups is zero, or a new measurement value. The absorbance ratio $[A_m]$ of the carbonyl group, the age $[A]$ at the time of measurement, and the new value are connected by a straight line. The lifetime $[X]$ of the cable is the number of years to reach the absorbance ratio $[A_L]$ at the lifetime on linear extension. The remaining life $[X_{RL}]$ is obtained by subtracting the age $[A]$ from the lifetime $[X]$. However, the lifetime value $[V_L]$ of the carbonyl group is different for different manufacturers. It is possible that the difference in the amount of antioxidant mixed by each manufacturer creates a difference in lifetime value. Therefore, it is necessary to obtain the lifetime value from each manufacturer in advance. The methods are to conduct a heating test for each cable specification in advance. The effective absorption peak of standard spectrum is 1897 cm^{-1} , and the peak of carbonyl group is 1732 cm^{-1} . In addition, the effective absorption can also select other peaks that meet the conditions. The condition for standard spectrum is invariable absorption even if thermal oxidative degradation occurs. The condition for carbonyl group is absorption having a linear increase.

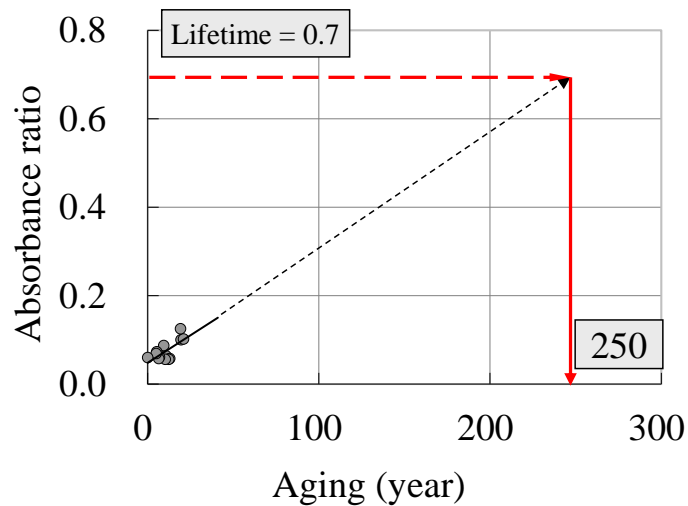
Fig 2.14 Relationship between the aging and the absorbance ratio (for CV cables made by Company A)

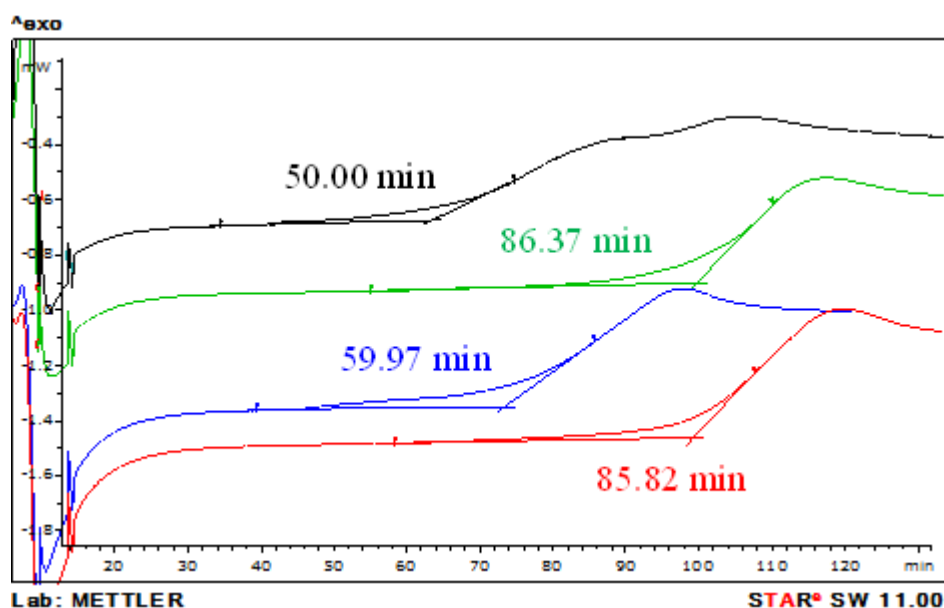
Fig 2.29 OIT charts of the same sample

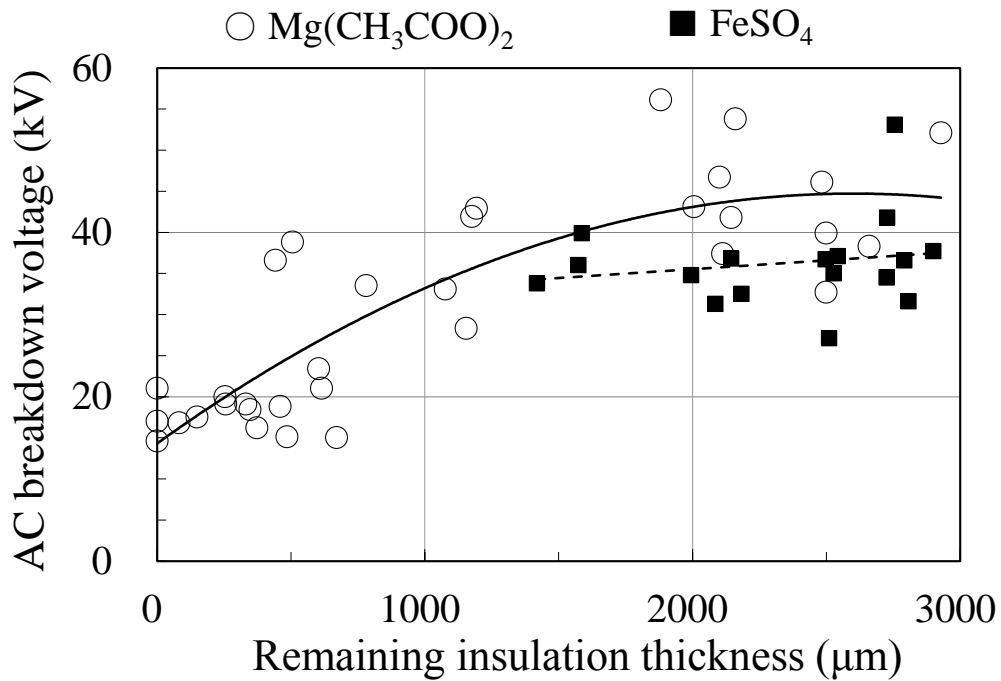
Fig 3.16 Relationship between AC breakdown voltage and remaining insulation thickness

Fig 3.16 shows the relationship between the AC breakdown voltage and the remaining insulation thickness. The electrolyte with the low breakdown voltage at the same remaining insulation thickness was iron sulfate (II). As the remaining insulation thickness reduced, the breakdown voltage values decreased in both electrolytes. In addition, the breakdown voltage values of bridging water trees in magnesium acetate were approximately 15–20 kV.

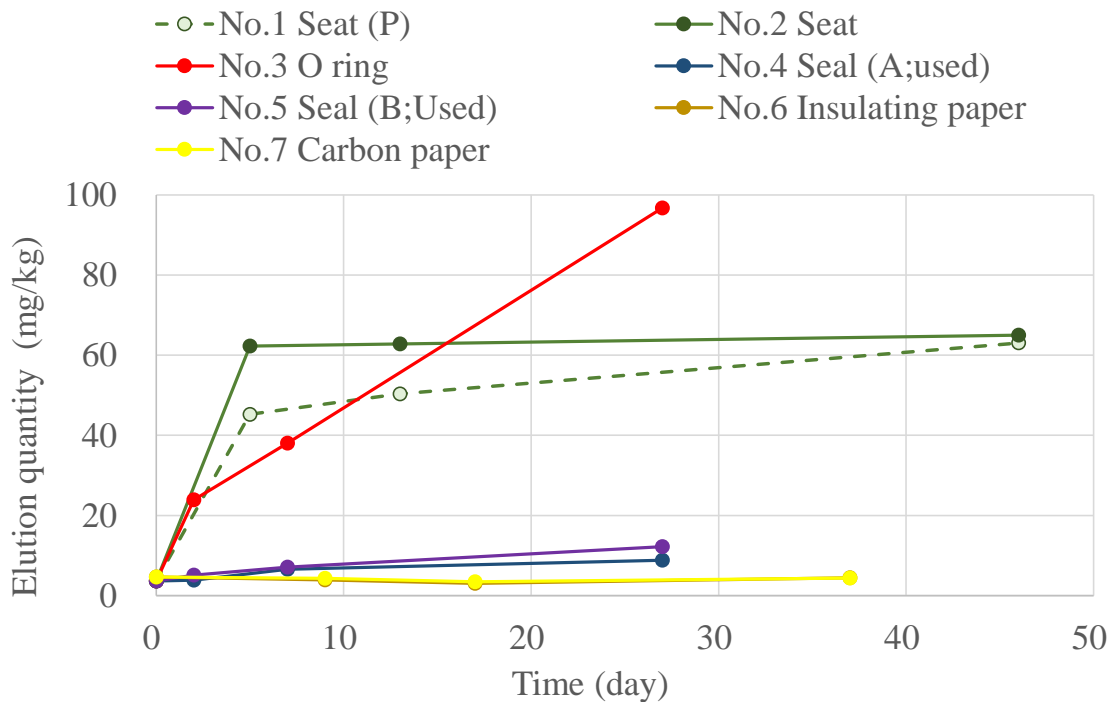
Fig 4.25 Change over time of eluted sulfur
