Paper:

Evacuation Behavior of Facilities for the Elderly in the Heavy Rain of July 2018

Junko Kanai[†] and Susumu Nakano

Tokushima University

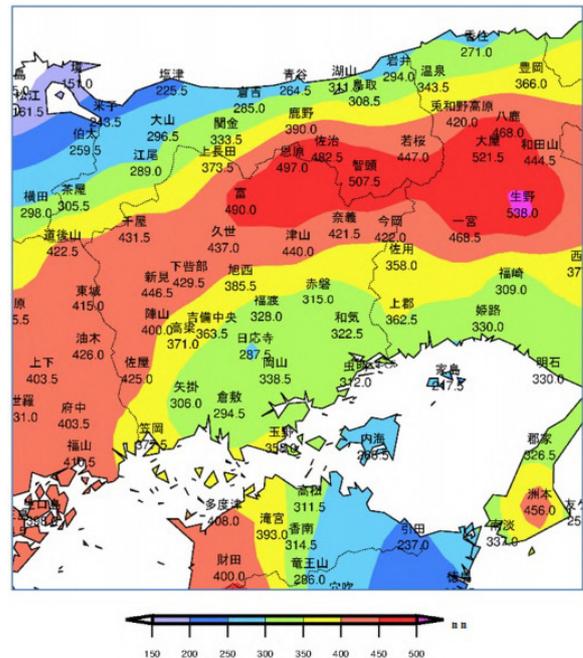
Fig. 1. Precipitation distribution from July 3 to 8 (Okayama Local Meteorological Observatory).

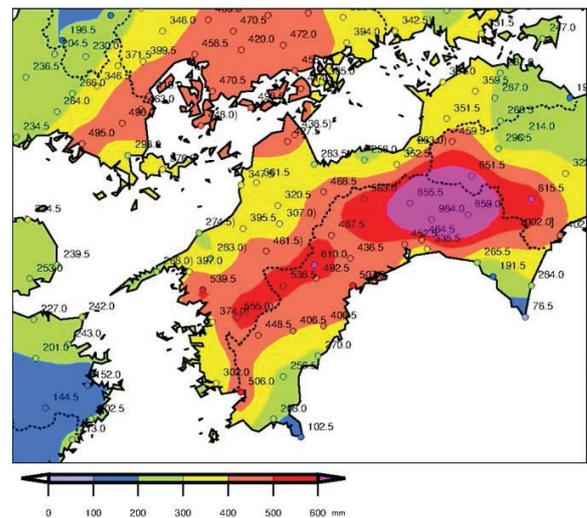
Fig. 2. Precipitation distribution from July 5 to 8 (Matsumayama Local Meteorological Observatory).

In Ehime Prefecture, the precipitation during the period from 0AM on July 5 to 12PM on July 8 was 571.0 mm in Chikanaga, Kihoku-cho, and 539.5 mm in Uwa, Seiyoshi (**Fig. 2**) [17]. The heavy rain caused 27 deaths, 625 completely destroyed houses, 3,018 partly destroyed houses, 187 inundated houses over the floor level, and 2,492 in-

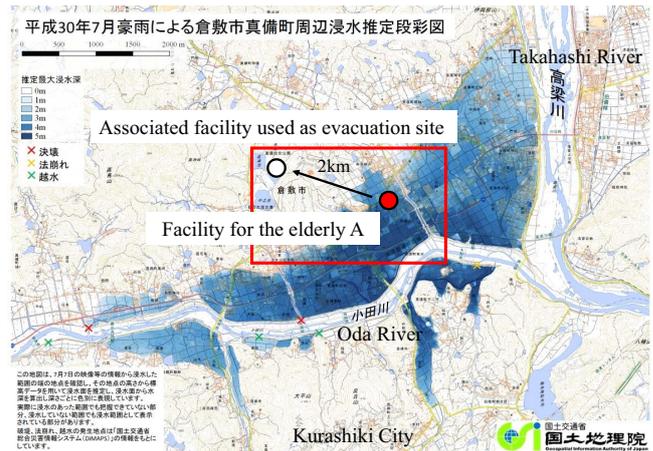
Fig. 3. Locations of inundated area and facility A in Mabi-cho (created by modifying a gradient tints diagram of inundation around Mabi-cho, Kurashiki-shi due to the heavy rain in July 2018 created by the Geospatial Information Authority of Japan).

Figure 3 shows the locations of the inundated area and the facility for the elderly, A (hereinafter referred to as facility A), in Mabi-cho. Figure 4 is a magnified map of the area enclosed by the red frame in Figure 3, showing the locations of facility A and Oda River. Table 3 shows the evacuation behaviors of the people from facility A. A warning about evacuation preparation and the start of the evacuation of elderly people and others was issued for people in mountain areas in Kurashiki-shi at 11:30AM on July 6. It was for areas at risk of landslide disaster and was irrelevant to facility A.

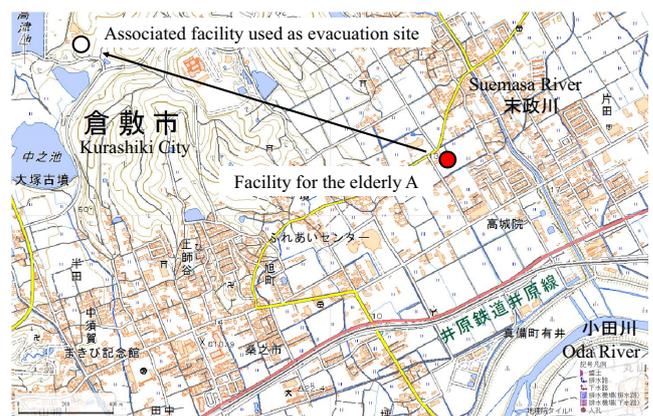
Fig. 4. Locations of facility A and Oda River.

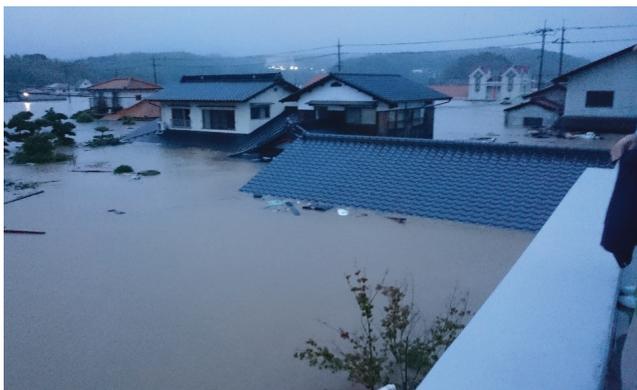
Fig. 5. View from the roof top at 5:01AM on July 7 (provided by the facility).

The facility staff were immediately assembled and began to transport the residents to an associated facility about 2 km away at around 10:45PM. The evacuation finished at 0:00AM. The staff then returned to the facility to take waterproofing measures for the equipment. Flooding began at around 0:30AM, and 25 of them were left on the roof top. **Fig. 5** was taken by a person left on the roof top at around 5AM on July 7 when the inundation height reached its peak; the photo shows the inundation around the facility. The staff were all rescued by a boat and helicopter 14 hours later.

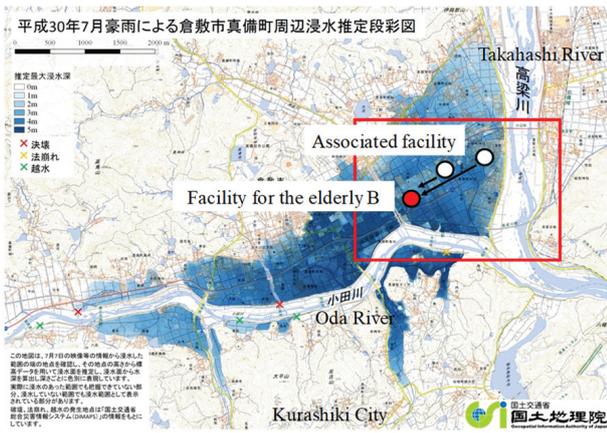
Fig. 6. Locations of inundated area and facility B in Mabi-cho (created by modifying a gradient tints diagram of inundation around Mabi-cho, Kurashiki-shi, due to the heavy rain in July 2018, developed by the Geospatial Information Authority of Japan).

Figure 6 shows the locations of the inundated area and the facility for the elderly B (hereinafter referred to as facility B) in Mabi-cho. **Fig. 7** is a magnified map of the area enclosed by the red frame in **Fig. 6**, showing the locations of facility B, Oda River, and Takahashi River. **Table 4** shows the evacuation behaviors of the people of facility B. As mentioned above, a warning about evacuation preparation and starting the evacuation of elderly people and others was issued for people in mountain areas in Kurashiki-shi at 11:30AM on July 6. It was irrelevant to facility B, which is located on flat land.

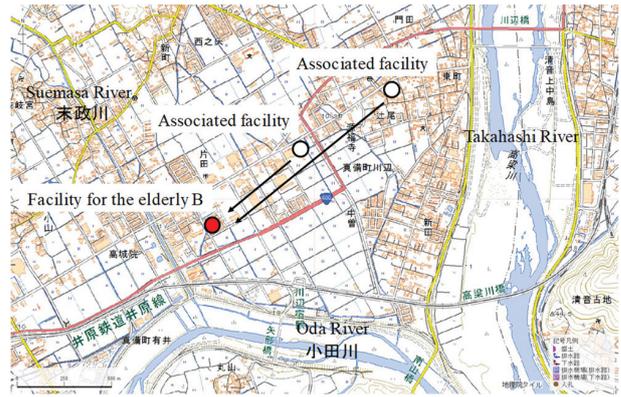
Fig. 7. Locations of facility B and Oda River.

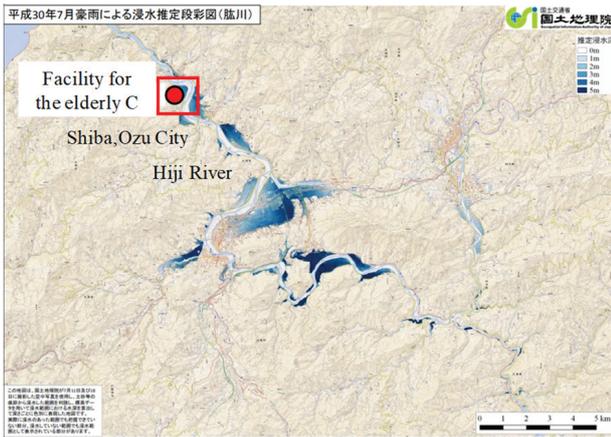
Fig. 8. Locations of inundated area and facility C around Hiji River (created by modifying a gradient tints diagram of inundation around Hiji River due to the heavy rain in July 2018 created by the Geospatial Information Authority of Japan).

Figure 8 shows the locations of the inundated area and the facility for the elderly C (hereinafter referred to as facility C) around Hiji River. Fig. 9 is a magnified map of the area enclosed by the red frame in Fig. 8, showing the locations of facility C, Hiji River, and Yoke River. Table 5 shows the evacuation behaviors of the people of facility C.

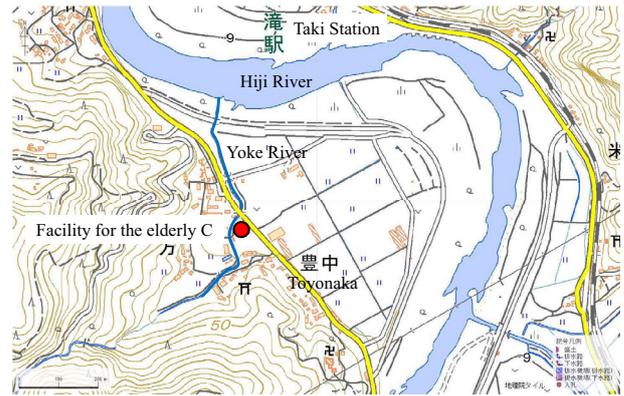
Fig. 9. Locations of facility C and Hiji River.

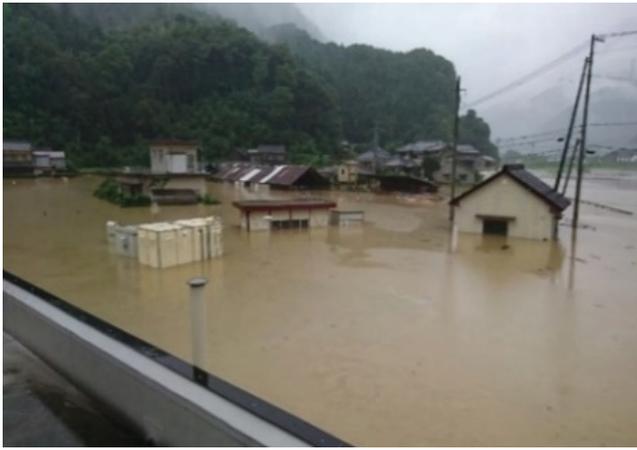
Fig. 10. View from a veranda on the second floor at 1:35PM on July 7 (provided by the facility).

The residents were moved to the second floor at 8AM. At 8:50AM, the staff heard from the municipal headquarters for disaster control that the discharge from Kano River Dam reached 3,700 m³/s. Therefore, the staff tried to transport the residents to an associated facility at 9AM but failed because of the inundation of the road. At 12:30PM, the inundation height around the facility was 20 cm and was increasing rapidly. It reached its peak at around 2PM. **Fig. 10** shows the surrounding situation of the facility; it was taken from a veranda on the second floor at 1:35PM, when the inundation height was reaching its peak.

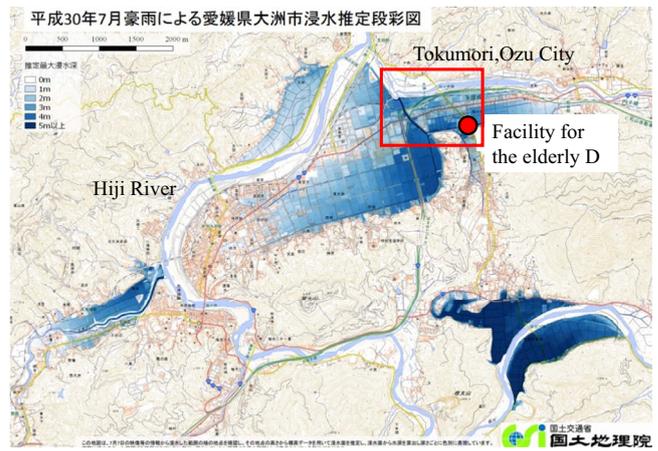
Fig. 11. Locations of flooded area near Hiji River and facility D (Created by modifying a gradient tints diagram of inundation around Hiji River due to the heavy rain in July 2018 created by the Geospatial Information Authority of Japan).

Figure 11 shows the locations of the inundated area and the facility for the elderly, D (hereinafter referred to as facility D), around Hiji River. **Fig. 12** is a magnified map of the area enclosed by the red frame in **Fig. 11**, showing the locations of facility D and Hiji River. **Table 6** shows the evacuation behaviors of the people of facility D.

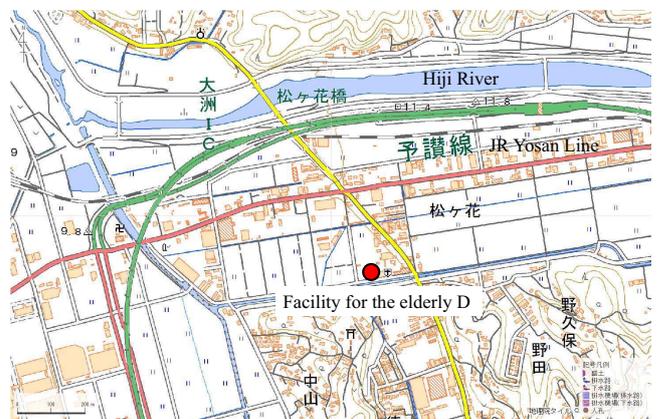
Fig. 12. Locations of facility D and Hiji River.

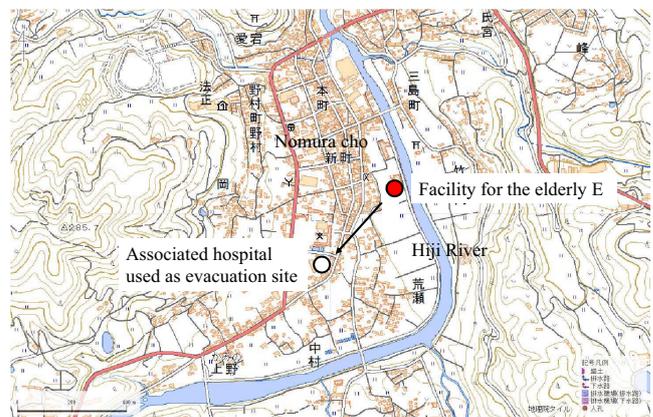
Fig. 13. Locations of facility E and Hiji River.

Figure 13 shows the locations of Hiji River and the facility for the elderly E (hereinafter referred to as facility E). Table 7 shows the evacuation behaviors of the people of facility E.

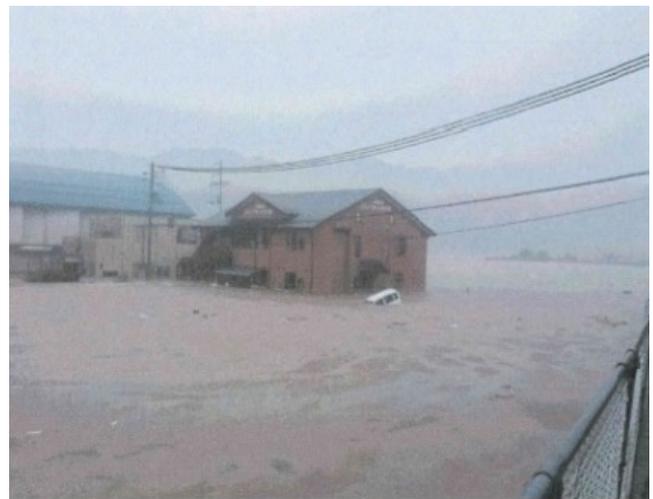
Fig. 14. View from a hill at around 7:10AM on July 7 (provided by the facility).

height reached 6 cm above the second-floor level. Fig. 14 of the facility was taken from a hill at around 7:10AM.

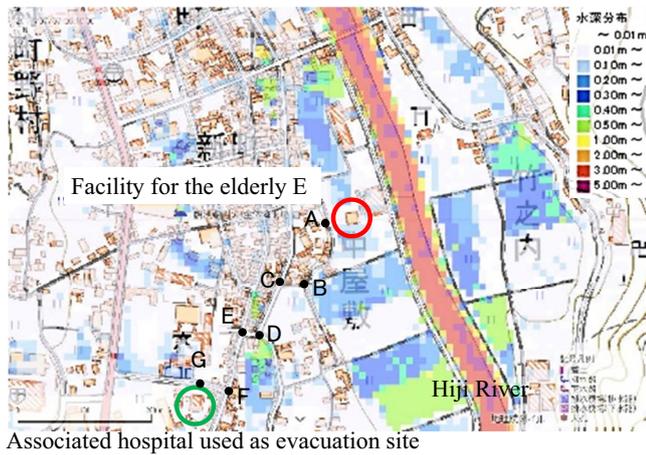
Fig. 15. Inundation at 6:10AM on July 7 (when the people of facility E finished evacuating).

Figures 15 to 18 show the inundation conditions around facility E in chronological order. Fig. 15 shows the inundation at 6:10AM when the evacuation of the people of facility E was finished. The road to the associated hospital to which they evacuated was not inundated and therefore they could evacuate by car.

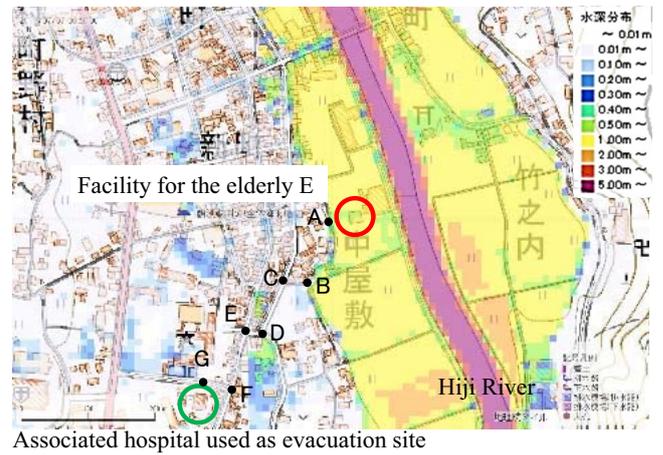
Fig. 16. Inundation at 6:50AM on July 7 (when the inundation of facility E began).

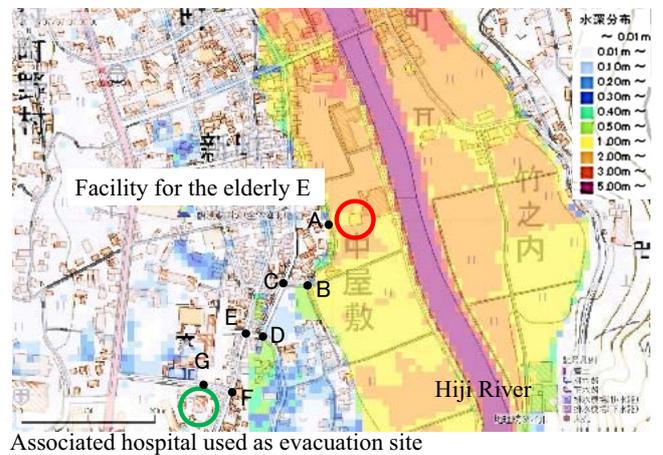
Fig. 17. Inundation at 7:00AM on July 7.

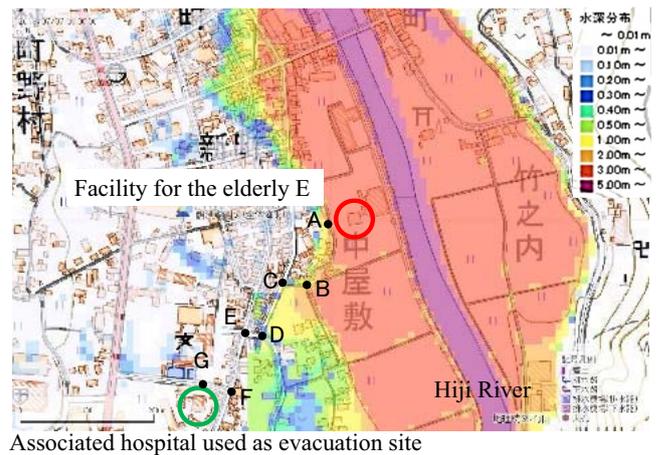
Fig. 18. Inundation at 8:00AM on July 7.

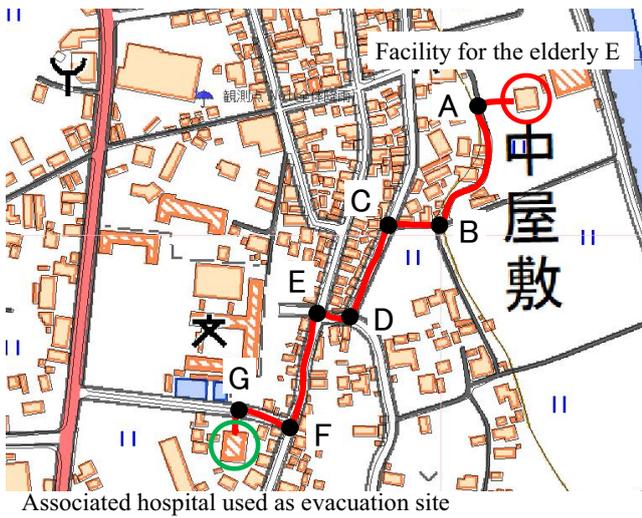
Fig. 19. Evacuation route from facility E.

Figure 19 indicates with a red line the evacuation route from facility E to the associated hospital to which the residents were evacuated. The distance between them was 605 m, and the difference in elevation was about 10 m.

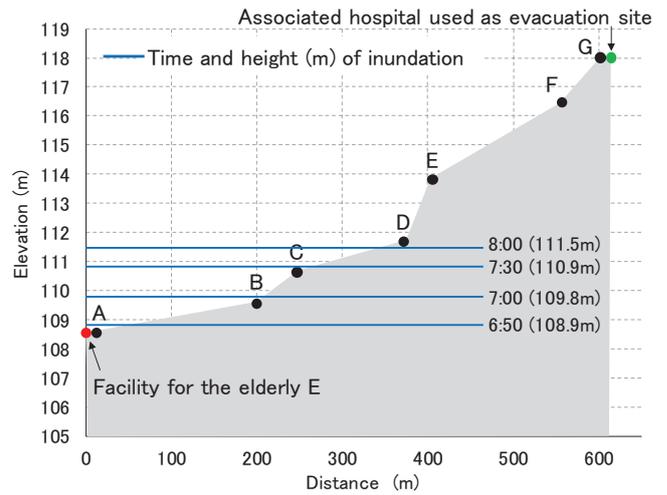
Fig. 20. Temporal change of inundation height along the evacuation route.

Figure 20 shows a temporal change in the inundation height along the evacuation route. The inundation height indicated by the blue line was determined by the inun-

ation height at facility E. At 6:50AM, 40 minutes after the people at facility E finished evacuating, the inundation began, and site A was inundated. Site B was inundated at 7AM and site C at 7:30AM. At 8AM, the flood water had almost reached site D.

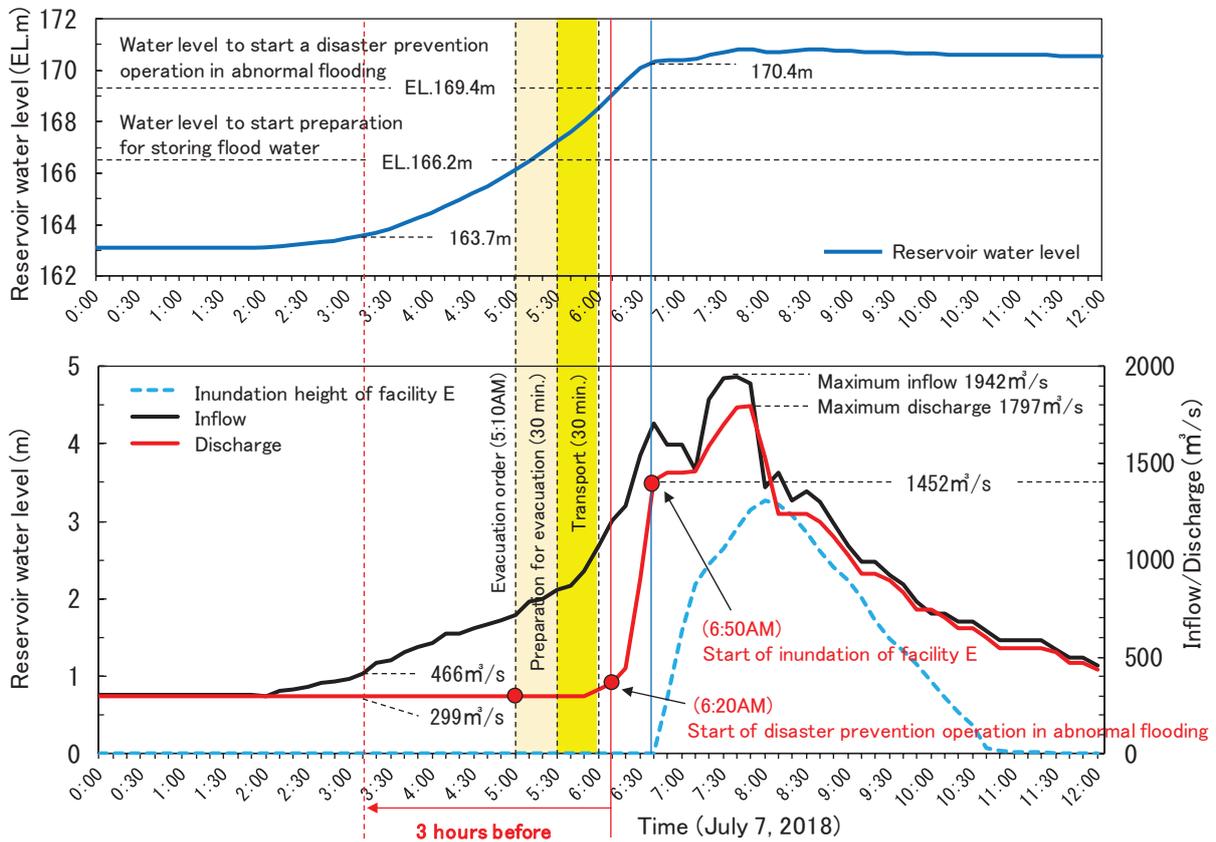
Fig. 21. Situation of Nomura Dam, evacuation behavior of facility E, and inundation condition.

Figure 21 shows the situation of Nomura Dam, the evacuation behavior of facility E, and the inundation condition from 0AM to 12AM on July 7.
